PIC32MZ Embedded Connectivity (EC) Family Silicon Errata and Data Sheet Clarification

The PIC32MZ Embedded Connectivity (EC) family devices that you have received conform functionally to the current Device Data Sheet (DS60001191C), except for the anomalies described in this document.

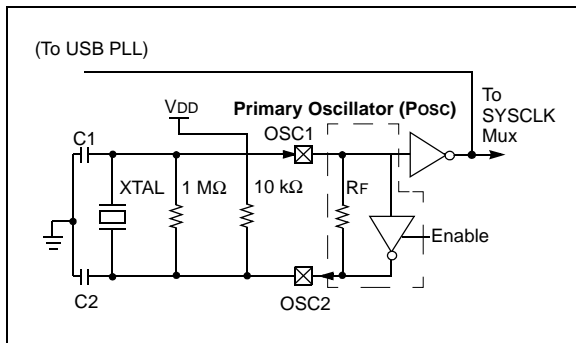
FIGURE 8-1: PIC32MZ EC FAMILY OSCILLATOR BLOCK DIAGRAM

The following figure shows the amended portion of the diagram.

Crystals with a speed of 4 MHz to 24 MHz that meet the following requirements will meet the PIC32MZ oscillation requirements when configured as depicted in [Figure 8-1](#).

1. Manufacturer Drive Level (min) < 10 μ W (hard requirements, 1 μ W preferred).
2. Manufacturer ESR \leq 50 Ω (hard requirement, lower is better).
